Aldridge Place Local Historic District

HISTORIC STRUCTURES SURVEY

ADDRESS: 100 W 32nd St.

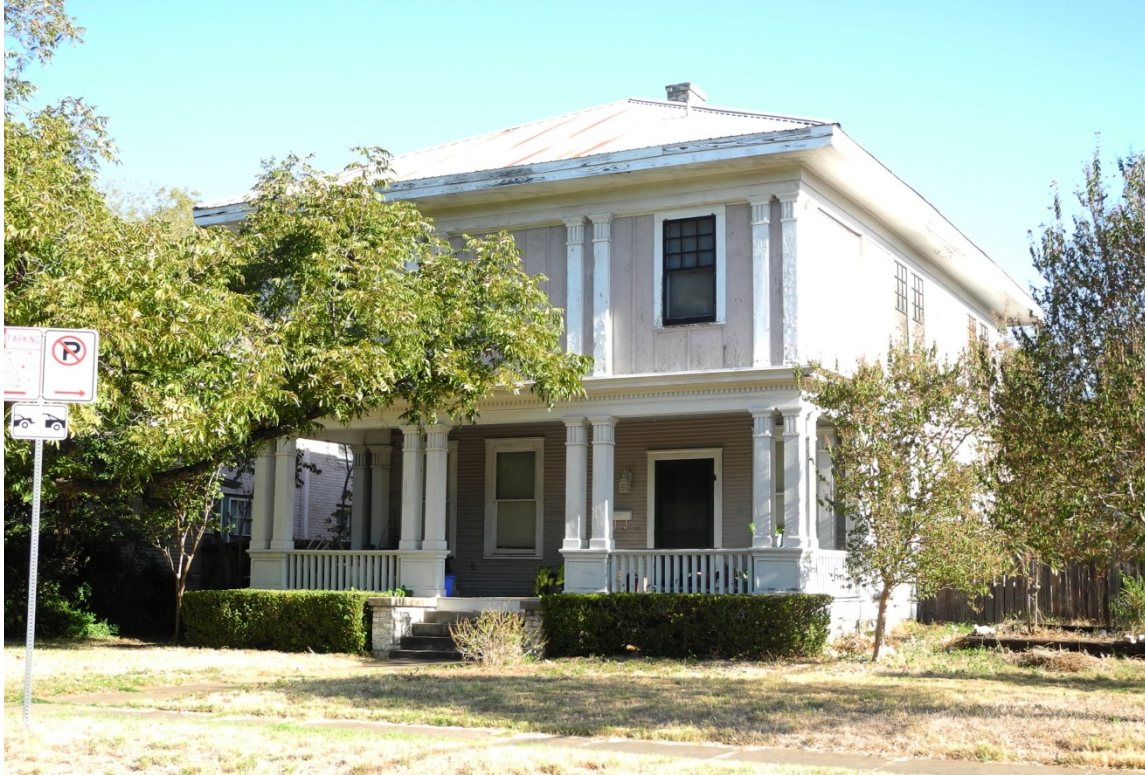
Two-story Prairie-influenced hipped roof house with deep eaves and a classical façade. Full-façade front porch supported by paired and tripled square posts and pilasters set on low pedestals. Second story porch with matching posts has been enclosed, possibly in the historic period. The house has false beveled wood siding with board-and-batten infill in the upper porch walls. Despite upper porch enclosure, the house retains its character, fabric, and integrity to a large degree and overall contributes to the historic district.

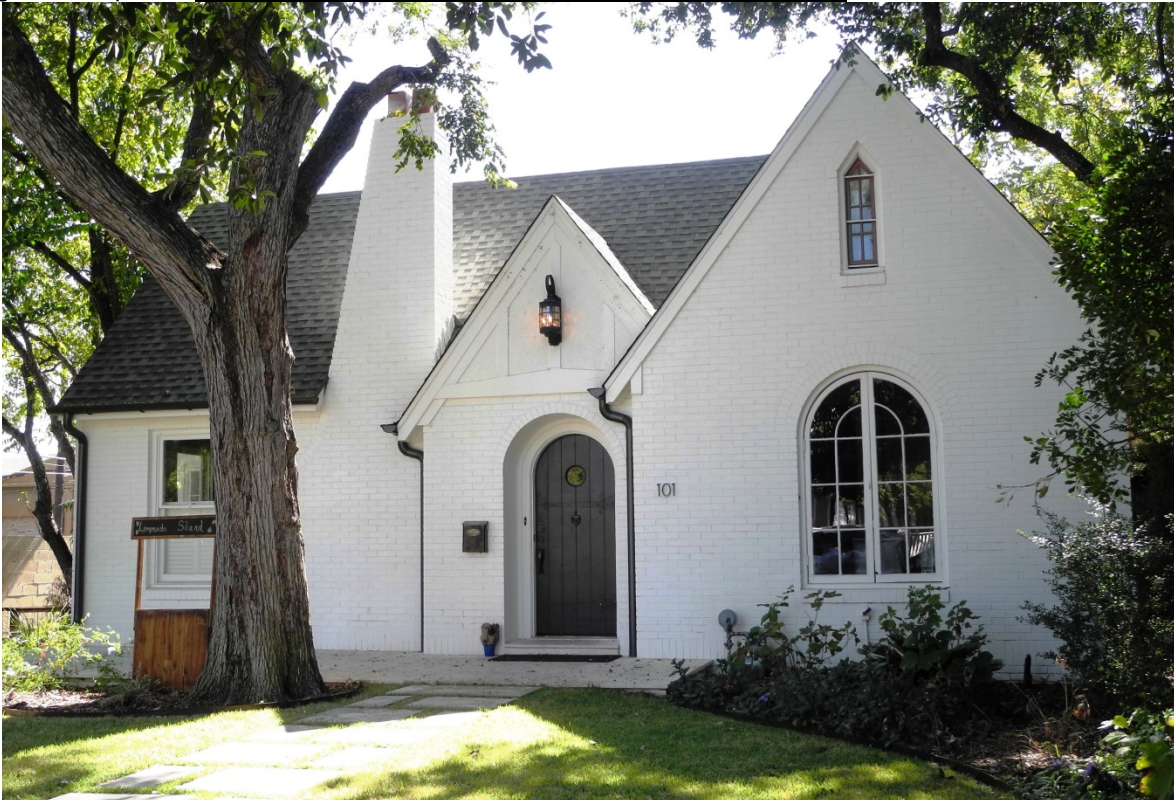
ADDRESS: 101 W 32nd St.

One story brick Tudor Revival house with high-pitched crossed gables; front-projecting wing with round-arched multi-light and lancet windows. Front-gabled round-arched brick entry bay with half-timbering and stucco, inset arched door. Tapered brick chimney on front façade, Sunroom with casement windows. Excellent, complex Tudor Revival style house retains high level of all 7 aspects of integrity, reflects historic and architectural trends of its time, and contributes to the historic district.

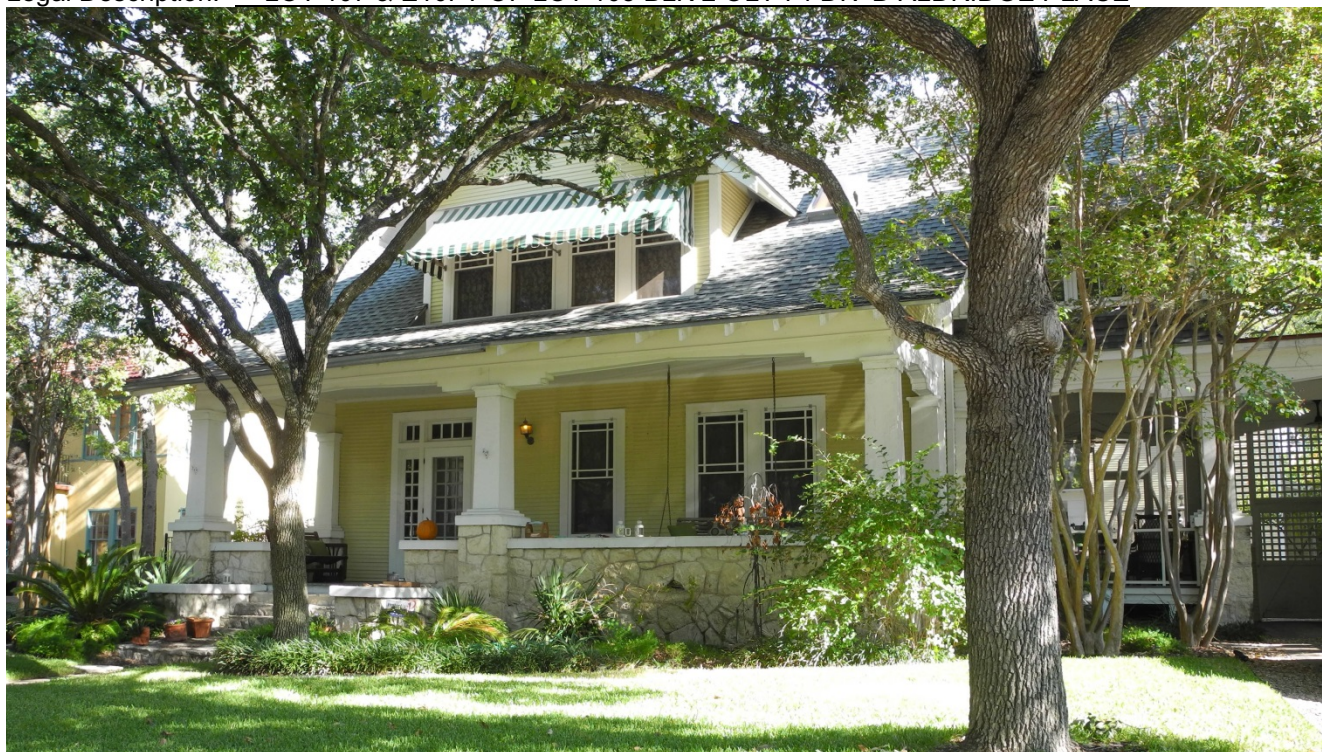
1½ story cross-gabled Craftsman bungalow with front-gabled dormer and full-façade front porch supported by slightly tapered wood posts on rusticated limestone piers and porch wall. False beveled siding and exposed rafter ends. Paired and single 1/1 windows; ribbon windows in dormer. Decorative screens. Side sleeping porch with enclosed 2nd story porch above. Porte cochere with tapered posts on stone pedestals. An excellent example of the Craftsman style, this house retains a high level of integrity, reflects historic and architectural trends of its time, and contributes to the historic district.

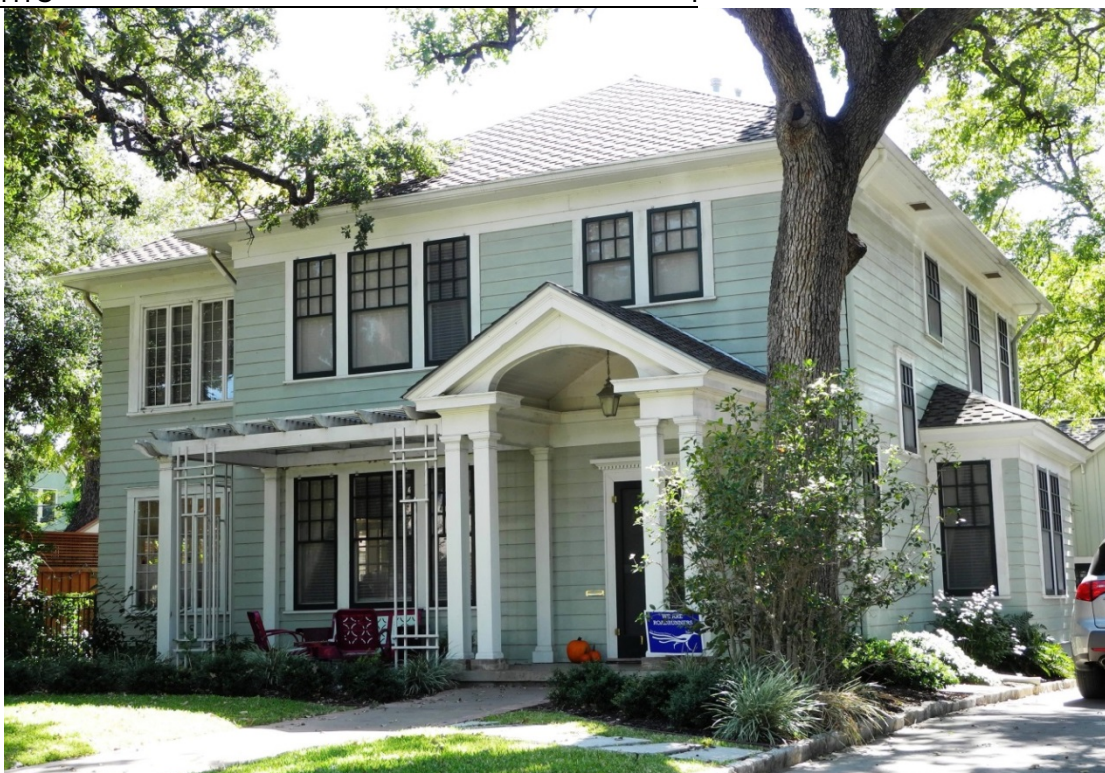
The Padgett-Painter House, built in 1925, is located in the University Heights section of Aldridge Place. The house exhibits elements of the Craftsman and Colonial Revival styles, both of which reached their zenith of popularity in the 1920s. The house has features of Craftsman buildings including an asymmetrical composition and paired and triple windows. But typical of Colonial Revival houses, it also has a pedimented portico with paired square wood posts. The Craftsman and Colonial Revival styles share a link to traditionalism: both hearkened to an earlier time and found their inspiration in the values which defined the nation before the Industrial Revolution and mass production.

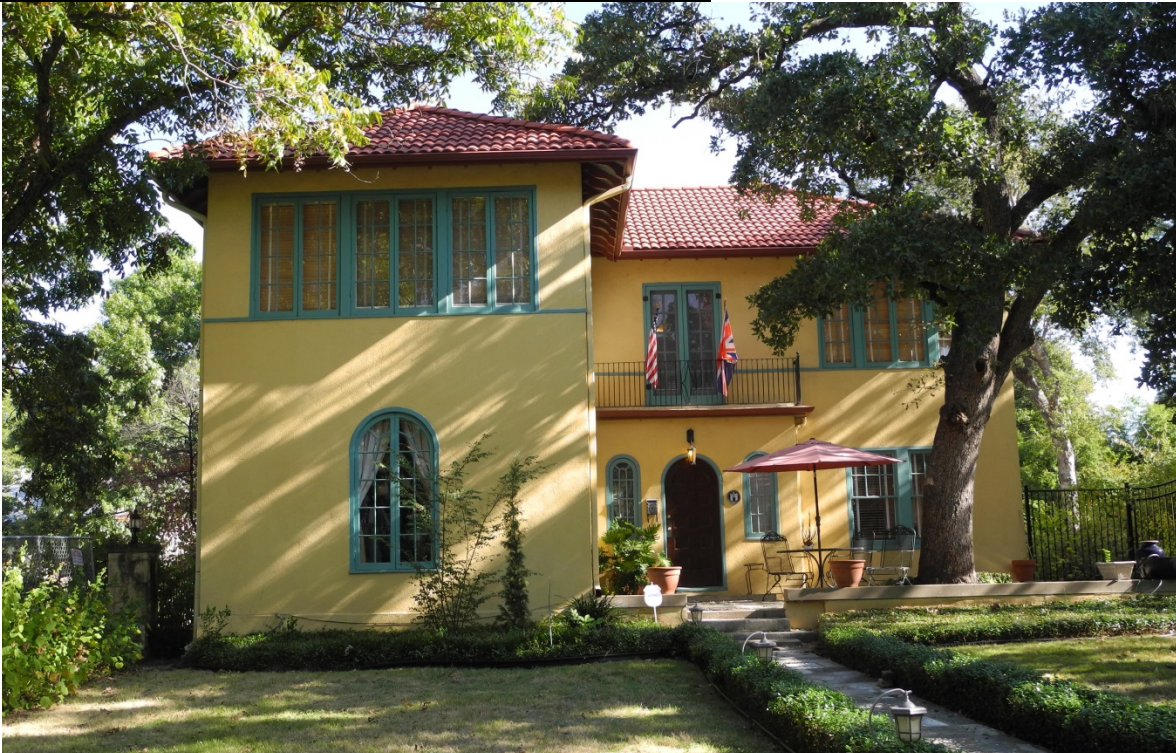
The ca. 1925 Bell-Flavey House is a Mediterranean villa designed by noted Austin architect Raymond Everett. The house is a two-story Mediterranean villa with stucco walls, a hipped tile roof, round-arched doors and windows on the ground floor, and wood casement windows on the second floor. The Bell-Flavey House, and Mediterranean villas generally, incorporated several features of traditional Spanish and Italian architecture, including tile roofs, round-arched windows and doors, and sunny areas with lots of light, including integral patios and sunrooms. The house also has notable interior ironwork by the Weigl Iron Works of Austin.

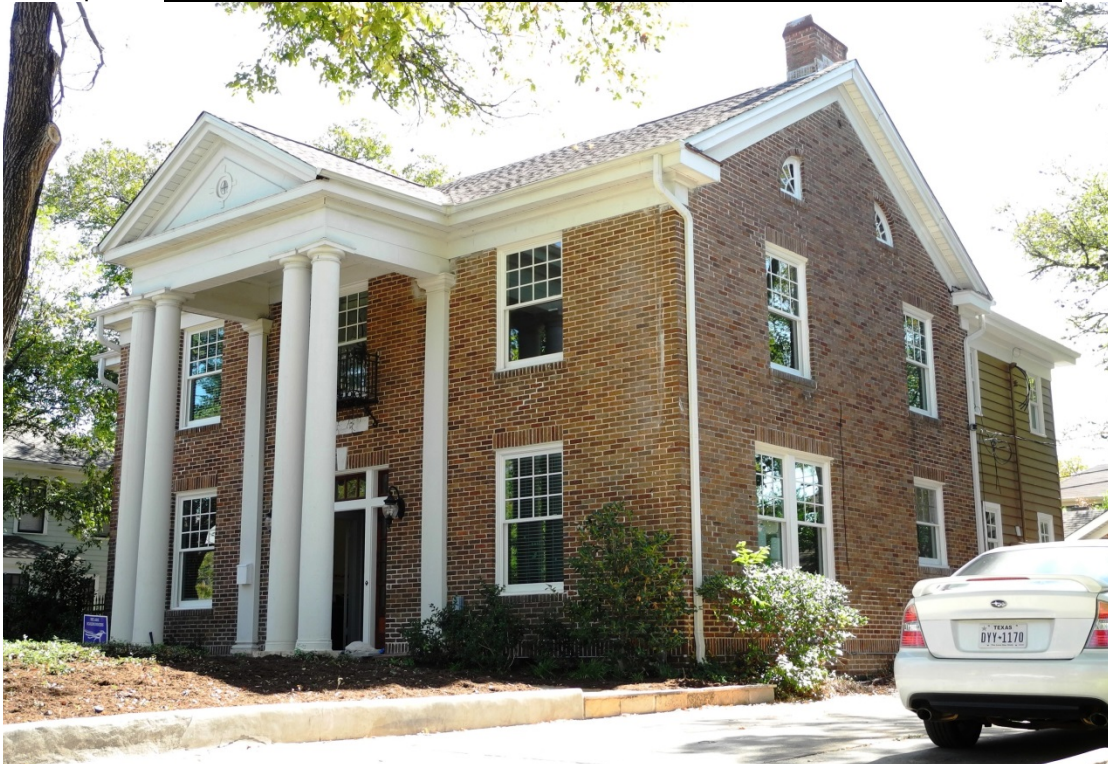
Two story cross-gabled Classical Revival brick house with dominant full height pedimented porch supported by paired Doric columns and square pilasters. Recessed 2-story side sunroom wing. Centered upper window with wrought iron balconet above glass door with keystone, transom, and sidelights. Replacement windows. Good, largely intact Classical Revival house retains high level of all 7 aspects of integrity, reflects historic and architectural trends of its time, and contributes to the historic district.

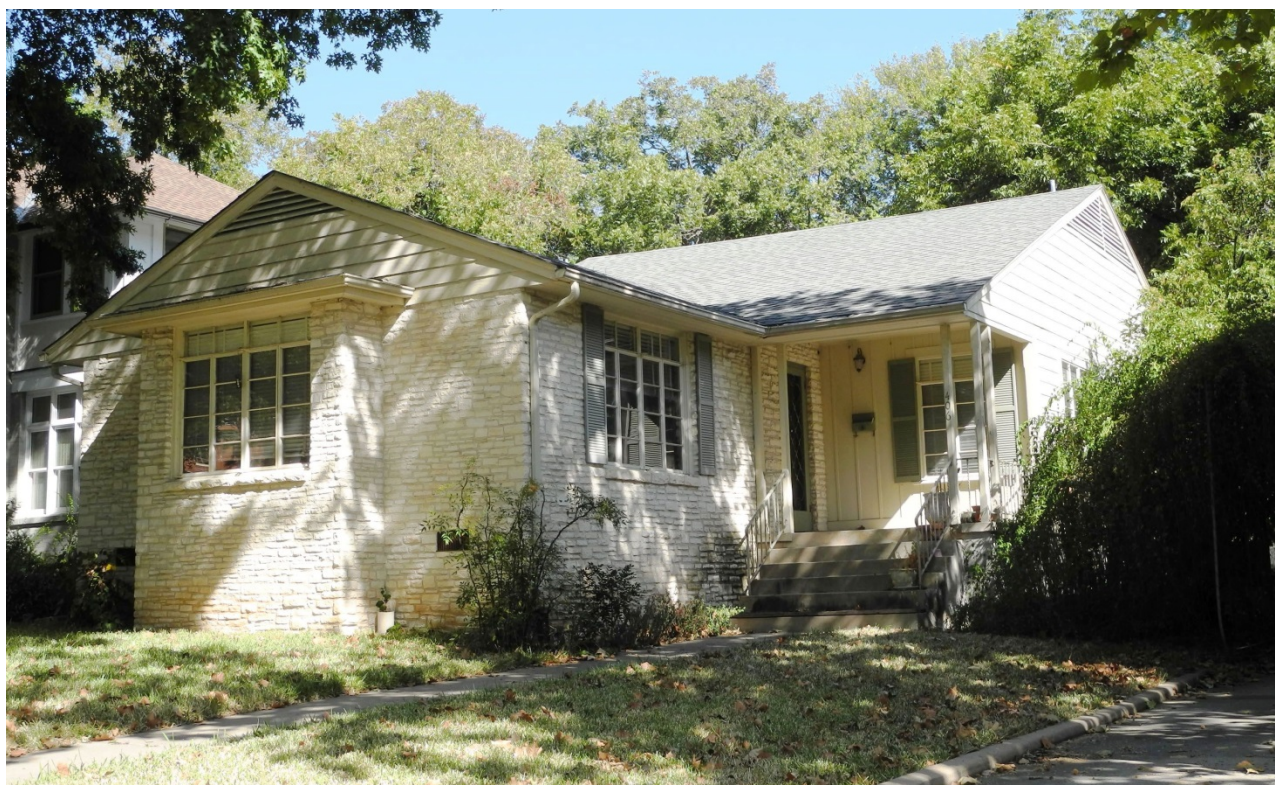
One story cross-gabled early Ranch Style L-plan house with side-gabled rear wing and a long, front-gabled projecting wing with small rectangular bay and casement windows. Deeply set back entrance porch at wing juncture. Rusticated stone on projecting wing, board and batten on rear porch wall, board siding on side walls and gable ends. Chamfered posts and pilasters support inset porch. Excellent, intact example of transition to Ranch Style architecture. Retains high level of all 7 aspects of integrity, reflects historic and architectural trends of its time, and contributes to the historic district.
